MARYLAND HISTORICAL TRUST

210143627
T-143

INVENTORY FORM FOR STATE HISTORIC SITES SURVEY

Crosiadore

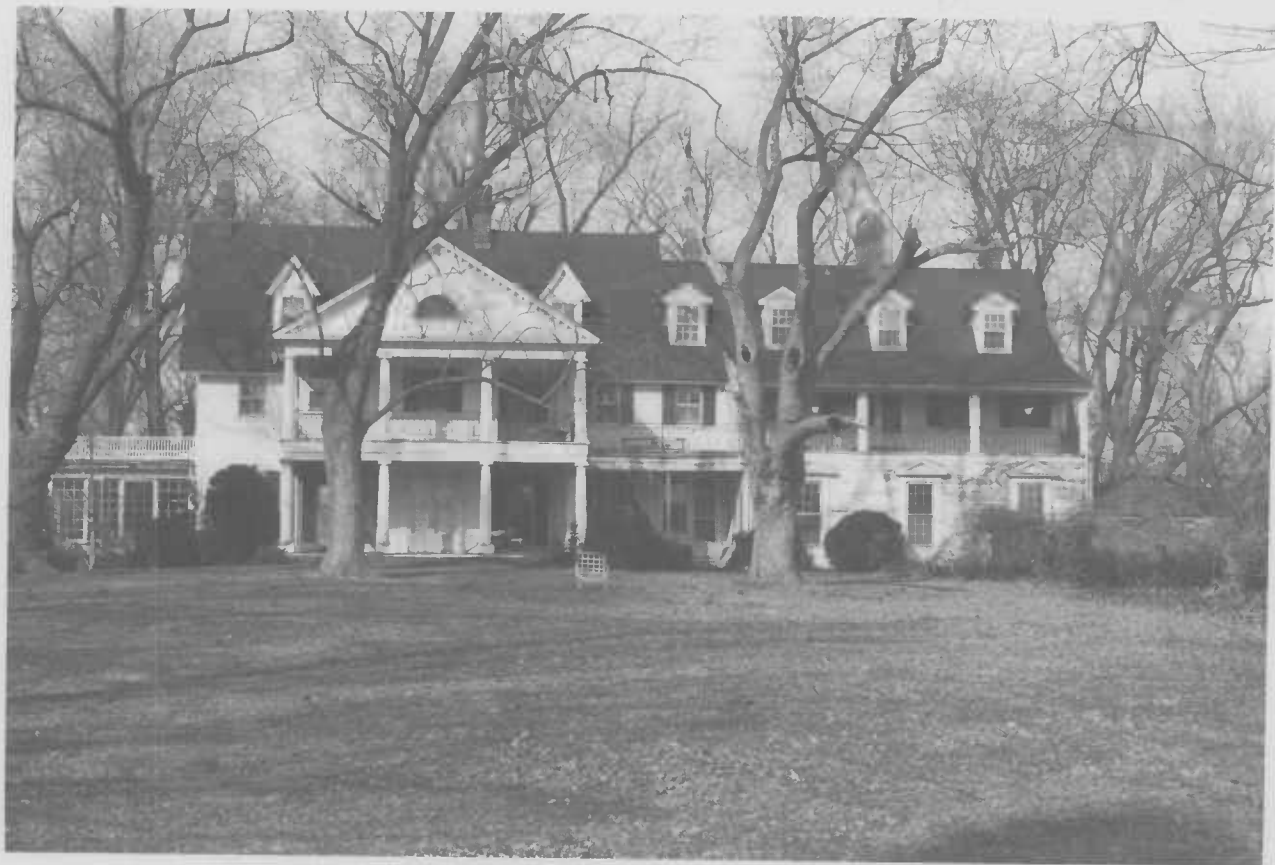
South facade

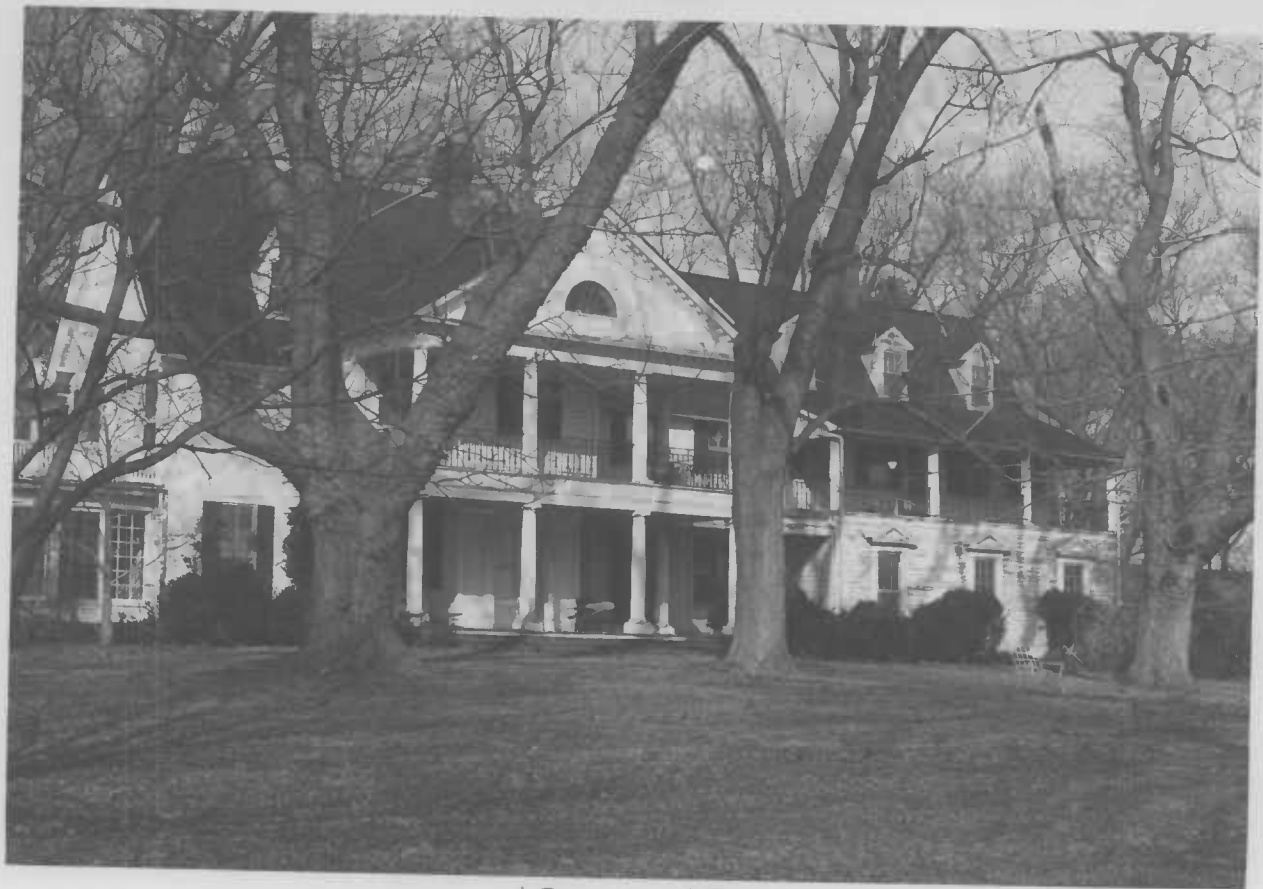
South facade

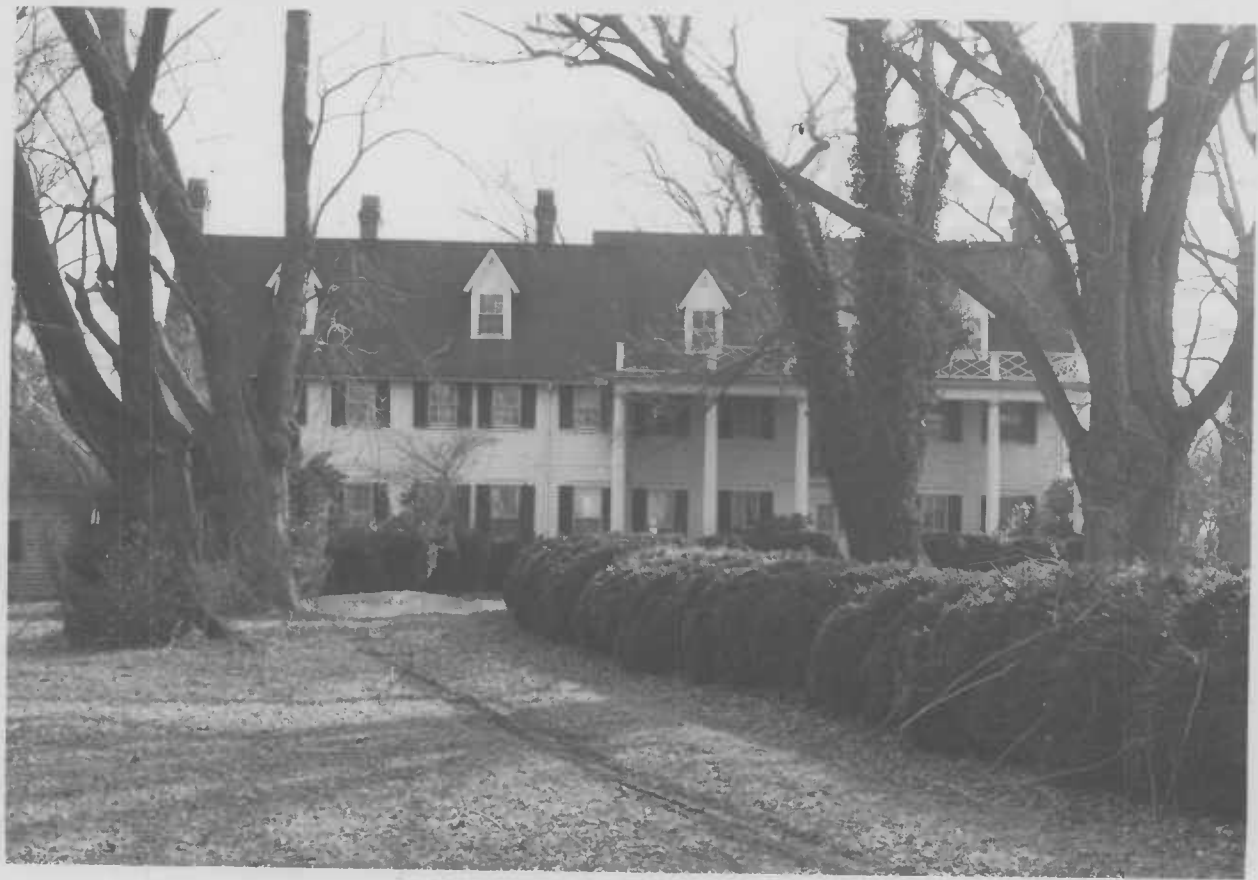
North facade

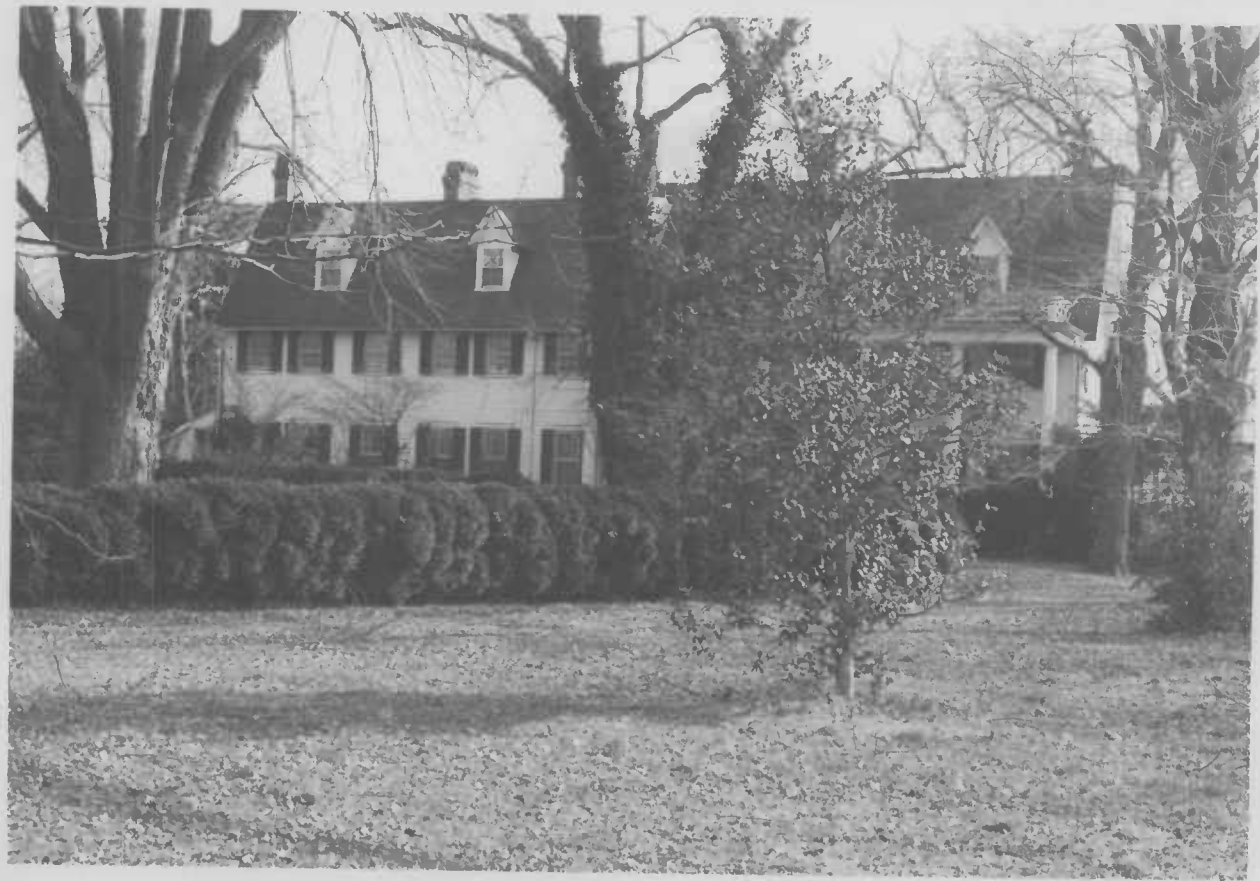
North facade

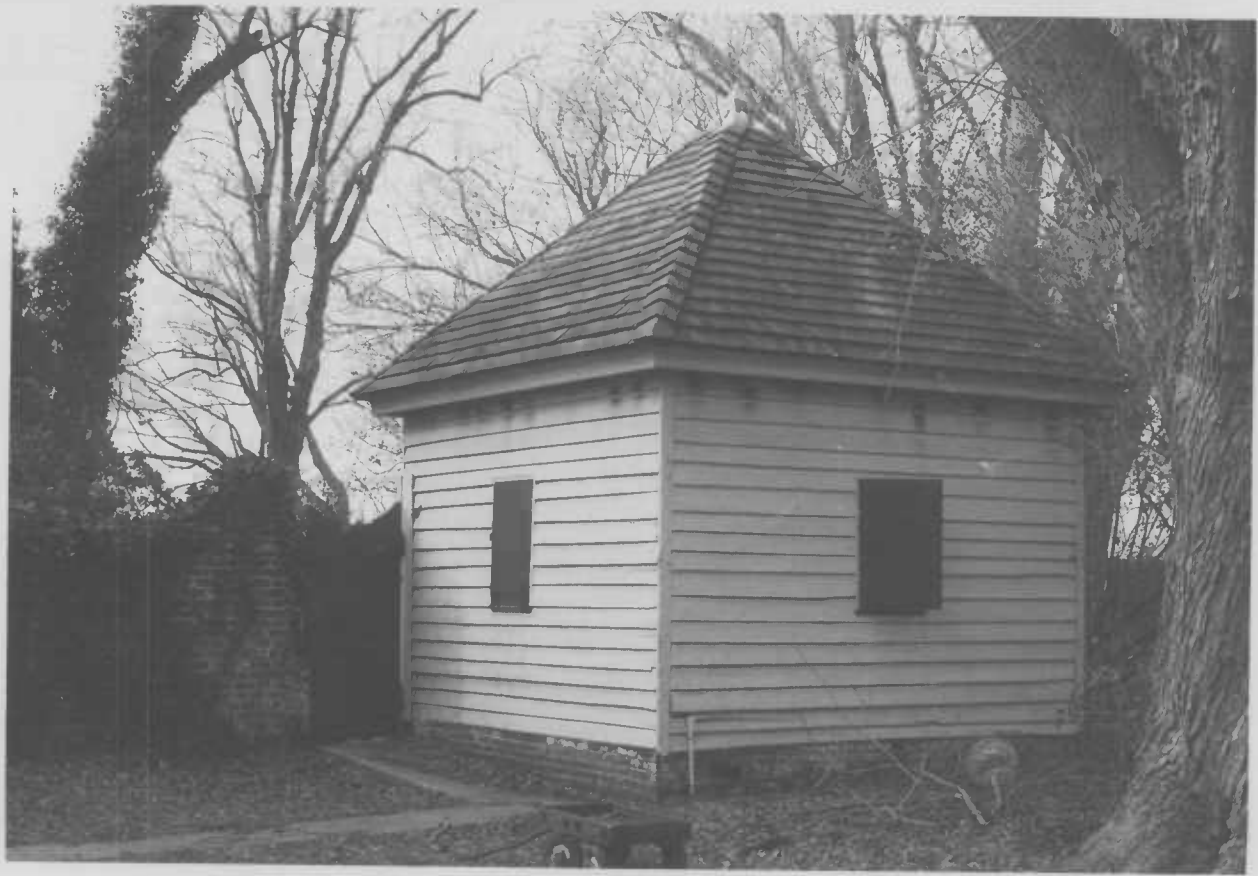
Crosiadore Dairy

A cellar exists only beneath the 1880's structure. An early 19th century dairy with pyramidal roof exists north of the east wing.

S. + E sides

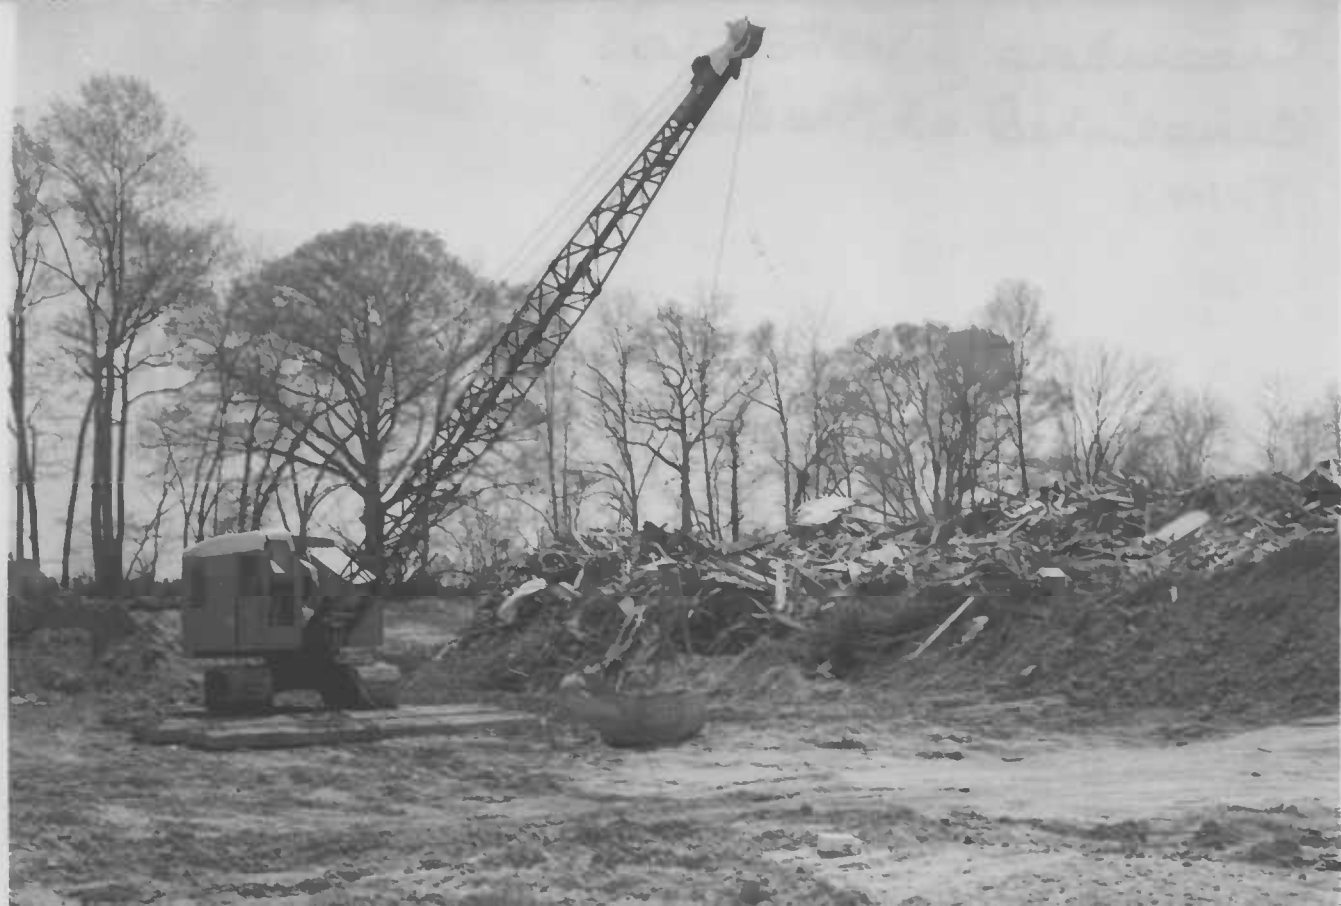
Crosiadora - Talbot Co.
demolished at the dump
